Manhole Inspection Summary

Manhole # S35UU_001MH

Insp Date: 1/11/07 11:31 AM

Location Address: **347 29TH ST**

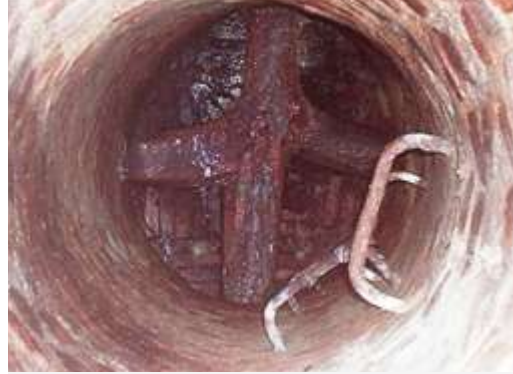
Top View

Corroded steps. Evidence of surcharge - Bench debris.

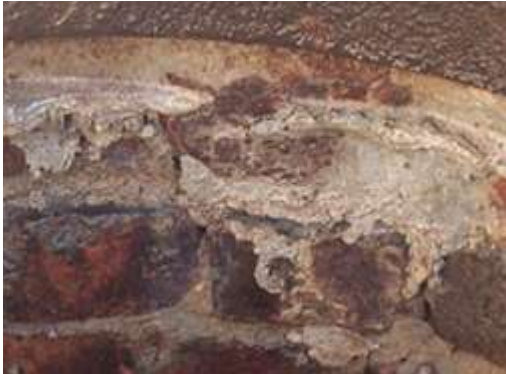
Defect

Frame leaks. Adjustment deterioration and infiltration.

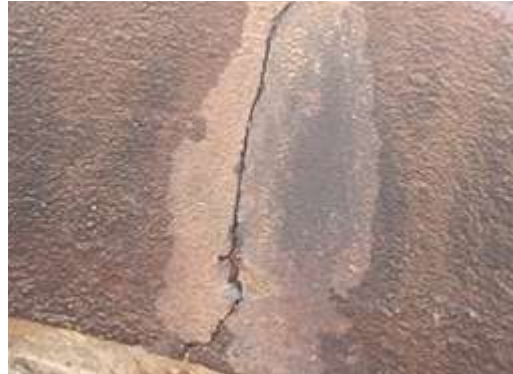
Defect

Frame crack and leaks.

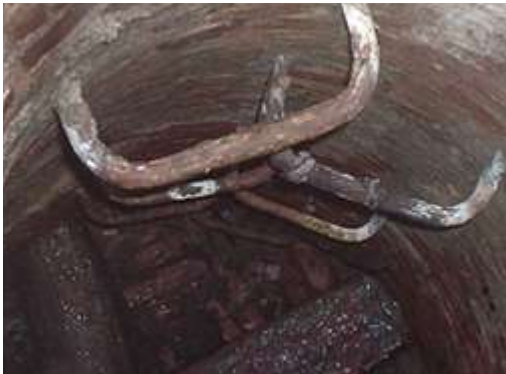
Defect

Adjustment infiltration.

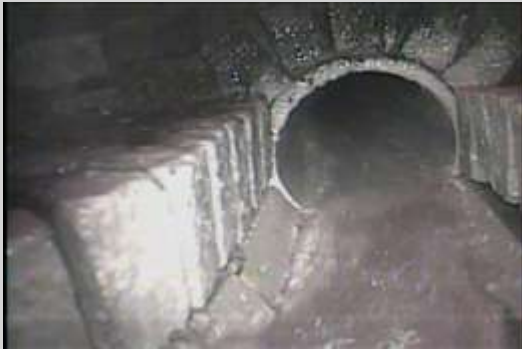
10 in. Circular Gravity Sewer Pipe Out @ 12 O'Clock

Channel deterioration.

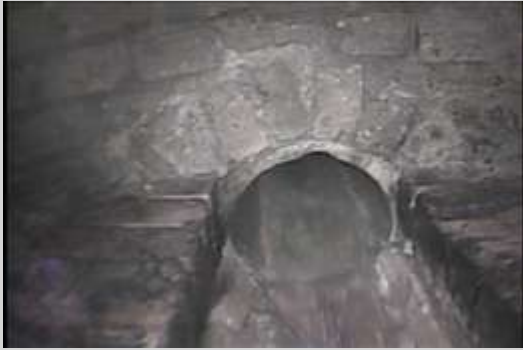
Pipe In @ 6 O'Clock

Deposits: ☐ None ☐ Mud ☐ Sludge ☐ Debris ☒ Grease

Silt Depth: **0** (in.) Deposits Extent: **Light**

Infiltration: **Evidence** Pipe Seal Cond: **Unknown**
